a guide for the  
geologic and hydrologic evaluation  
of small lake sites in missouri

MISSOURI DEPARTMENT OF NATURAL RESOURCES  
DIVISION OF GEOLOGY AND LAND SURVEY

Dean, Thomas J., James H. Barks and James H. Williams, 1976, A GUIDE FOR THE GEOLOGIC AND HYDROLOGIC EVALUATION OF SMALL LAKE SITES IN MISSOURI: Mo. Dept. of Natural Resources, Geological Survey, WR 31, 56 p., 24 figs., 2 app.

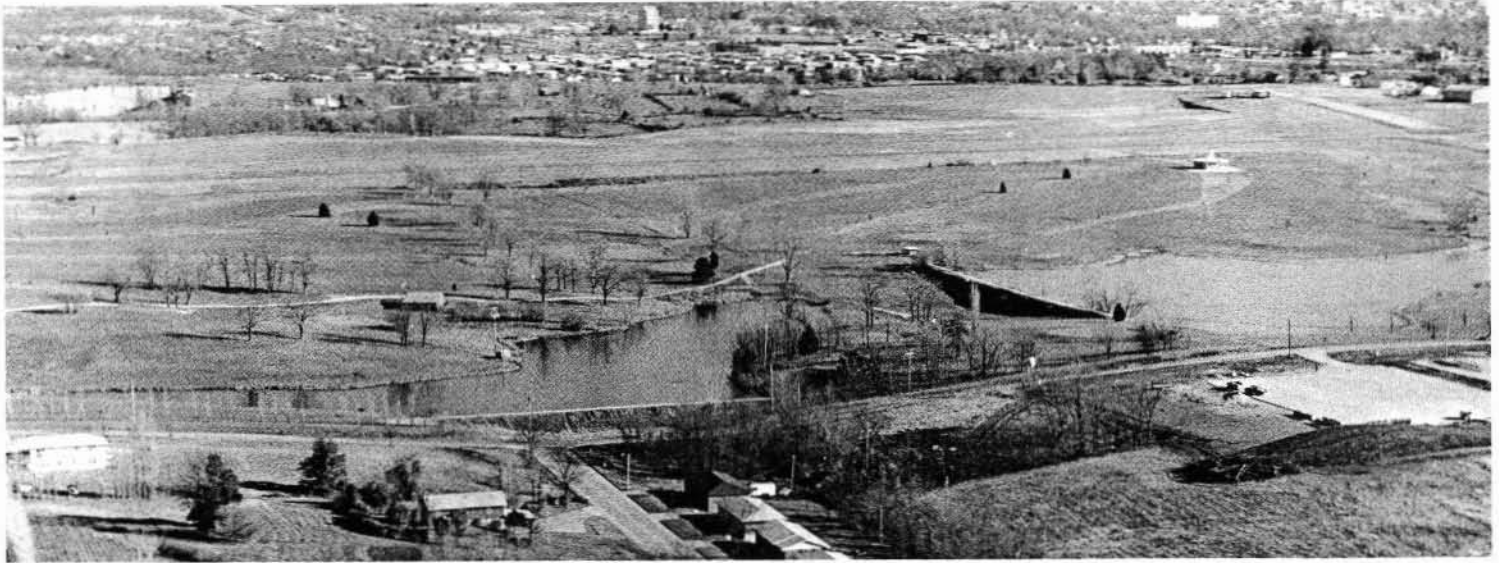
Figure 4

*Construction of a low dam creates a large lake in relatively flat areas with low relief topography. Photo by David Rath.*

Lakes in the upper watersheds of the Ozarks tend to be small (fig. 4) because

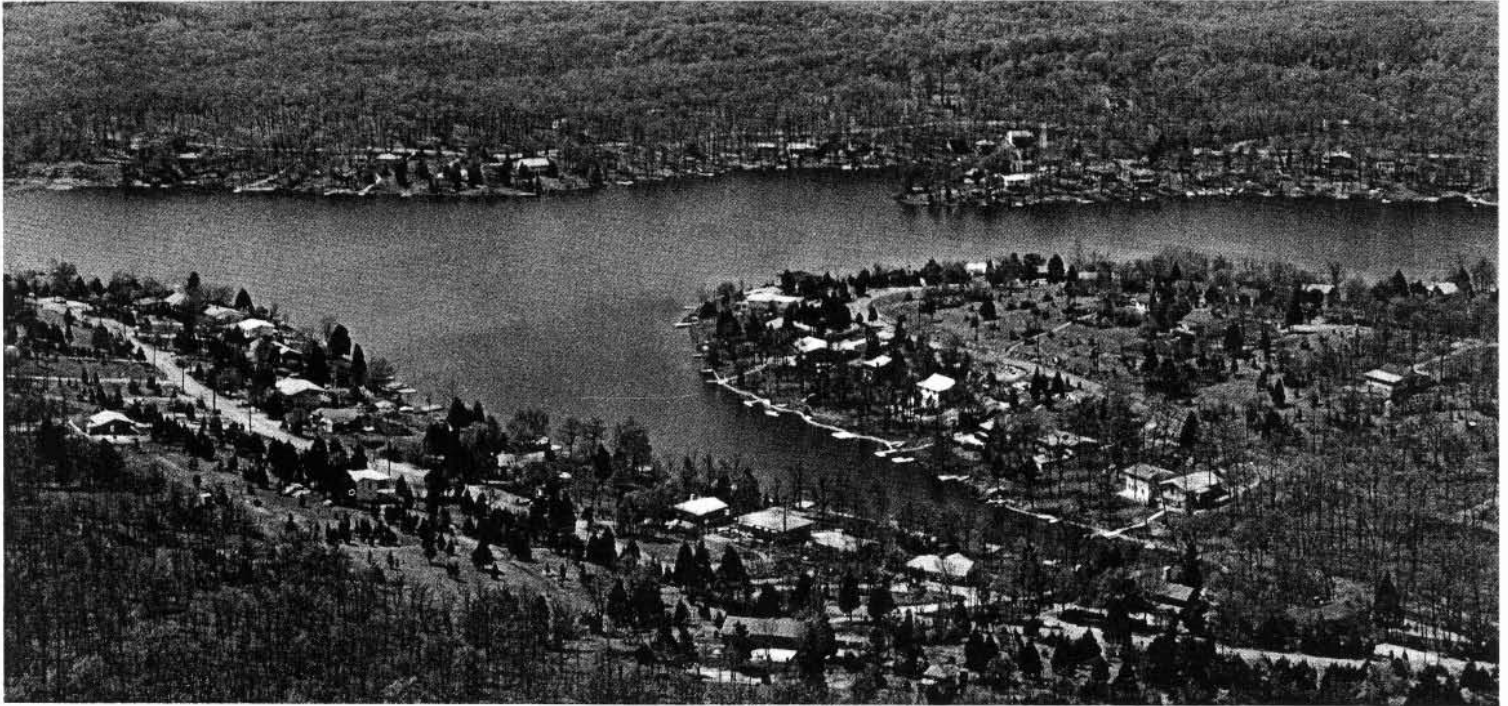
Figure 11

*Successful lakes such as this, where recreation and housing developments revolve around the lake, involve a high investment. Photo by Jerry D. Vineyard.*

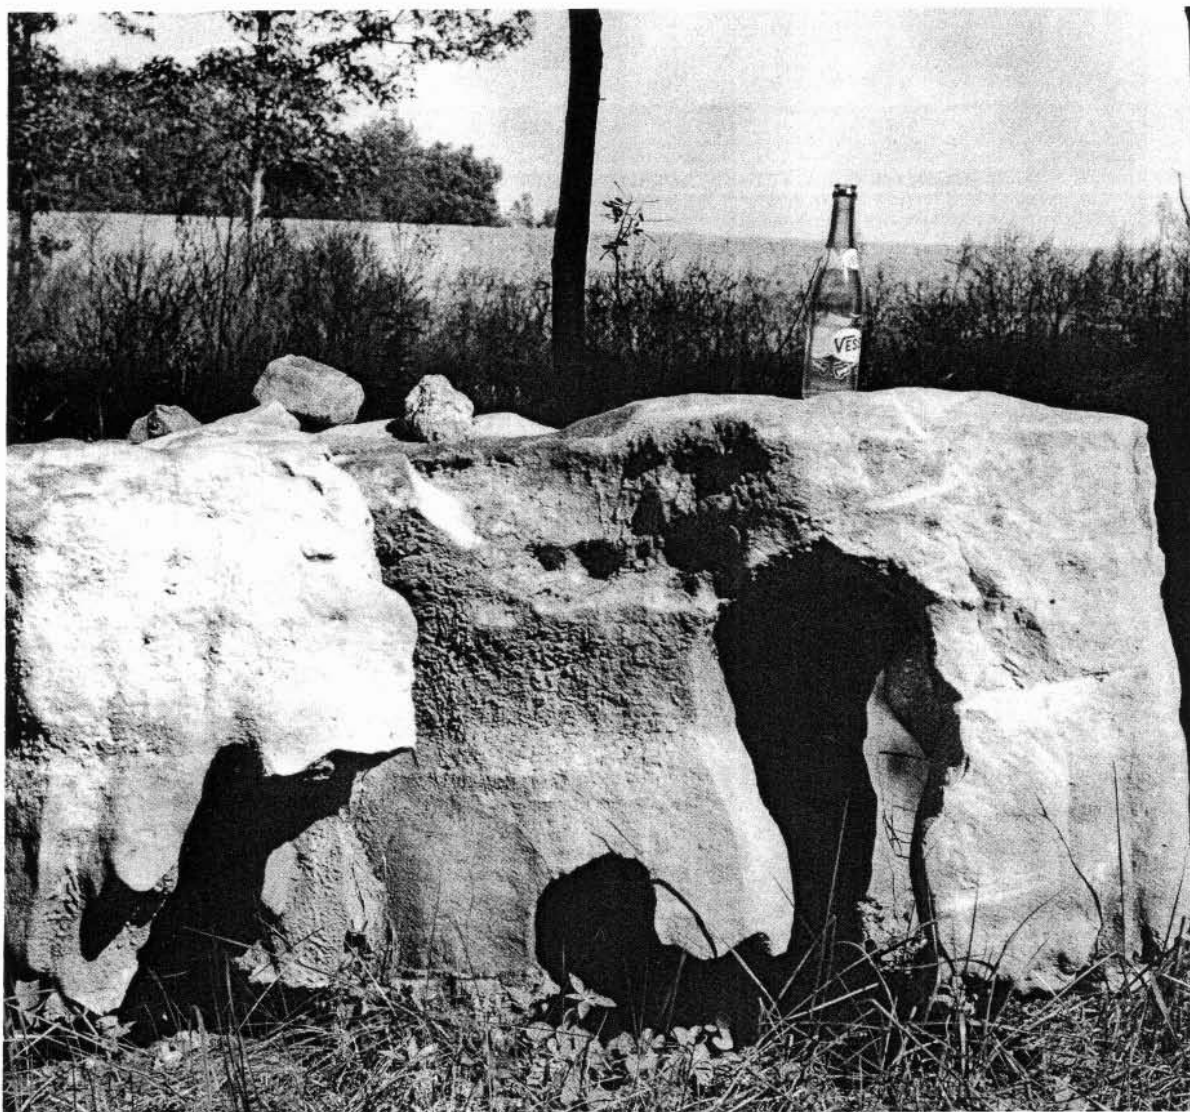
Figure 17

*Solution work caused by running water makes for a permeable lake bottom. Photo by Jerry D. Vineyard.*

Pinnacles (spire-shaped pillars of rock) are formed by solution along joints or cracks in the bedrock, or by differential weathering caused by abnormalities present in the rock. This phenomenon is not too unlike the sinkhole-cave relationship. The space between the pinnacles is not expressed on the surface as a depression, but rather as a filled depression (fig. 16). Thus, there may be no surface evidence of the problem. Bedrock may be present at the surface at one point, but 20 to 30 feet (6 to 9 m) away the soil may be many feet thick. The thick soil filling the crevice between the pinnacles is usually very permeable and may result in serious water loss from the lake (fig. 17).

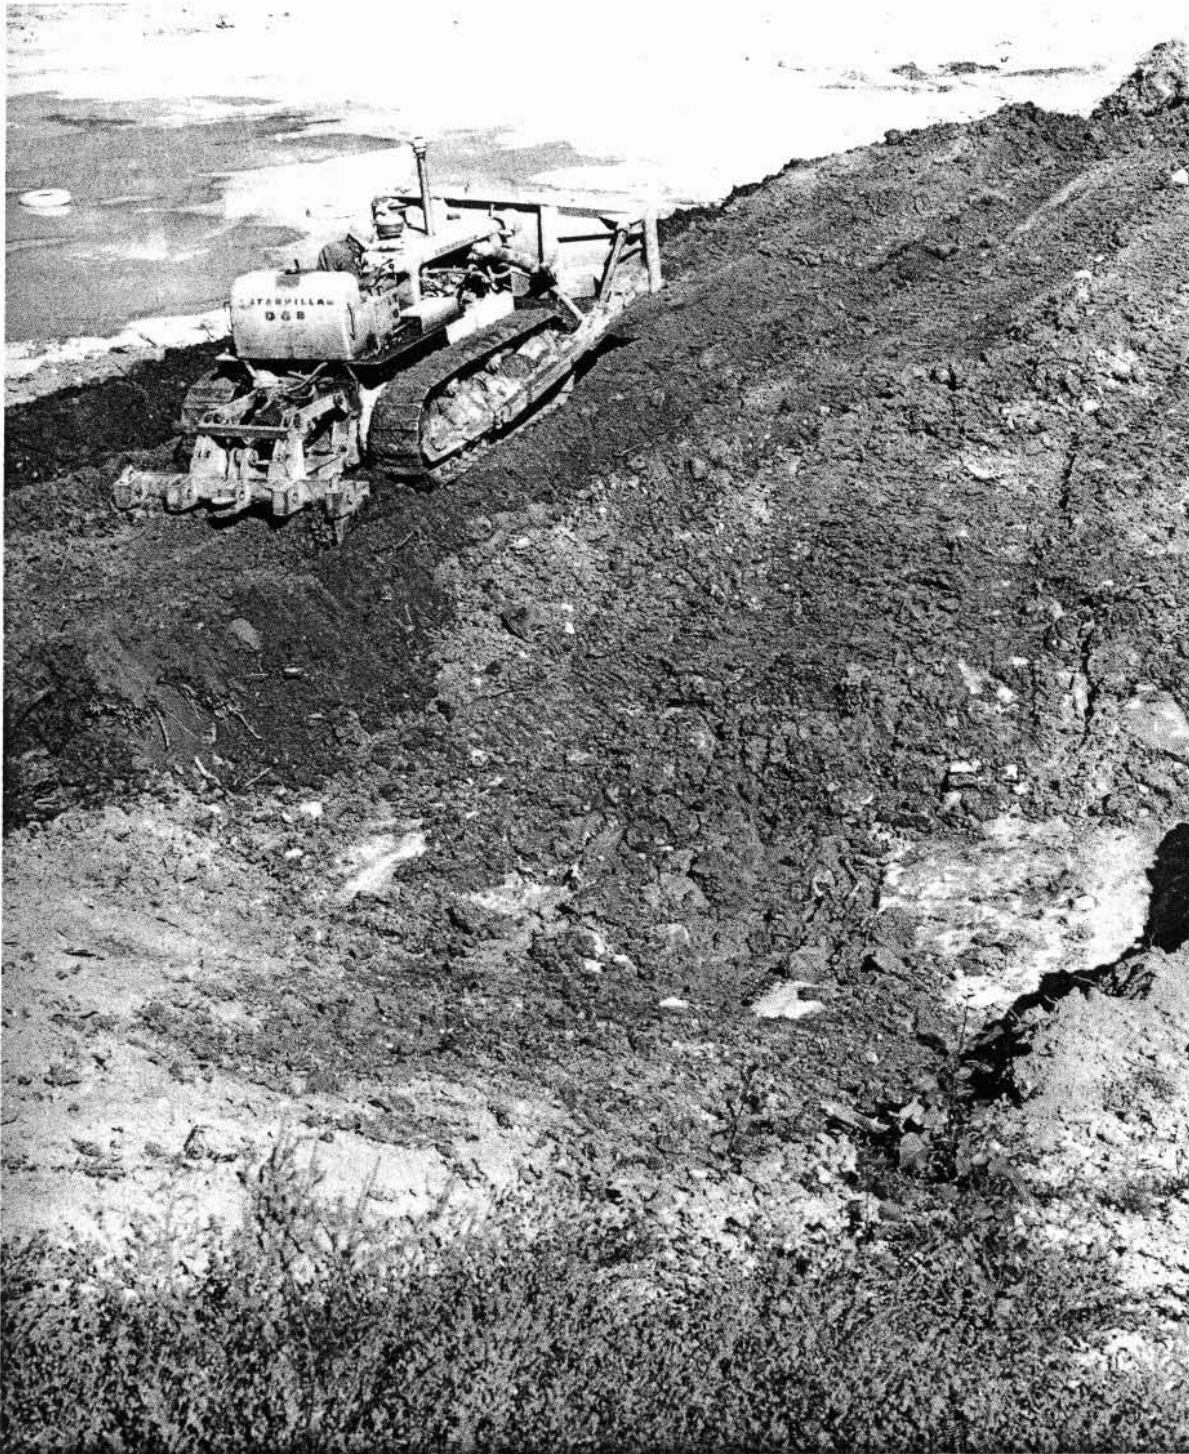
Figure 21

*A leaky lake can sometimes be repaired by sealing the permeable limestone rock in the lake bottom. Photo by Jerry D. Vineyard.*

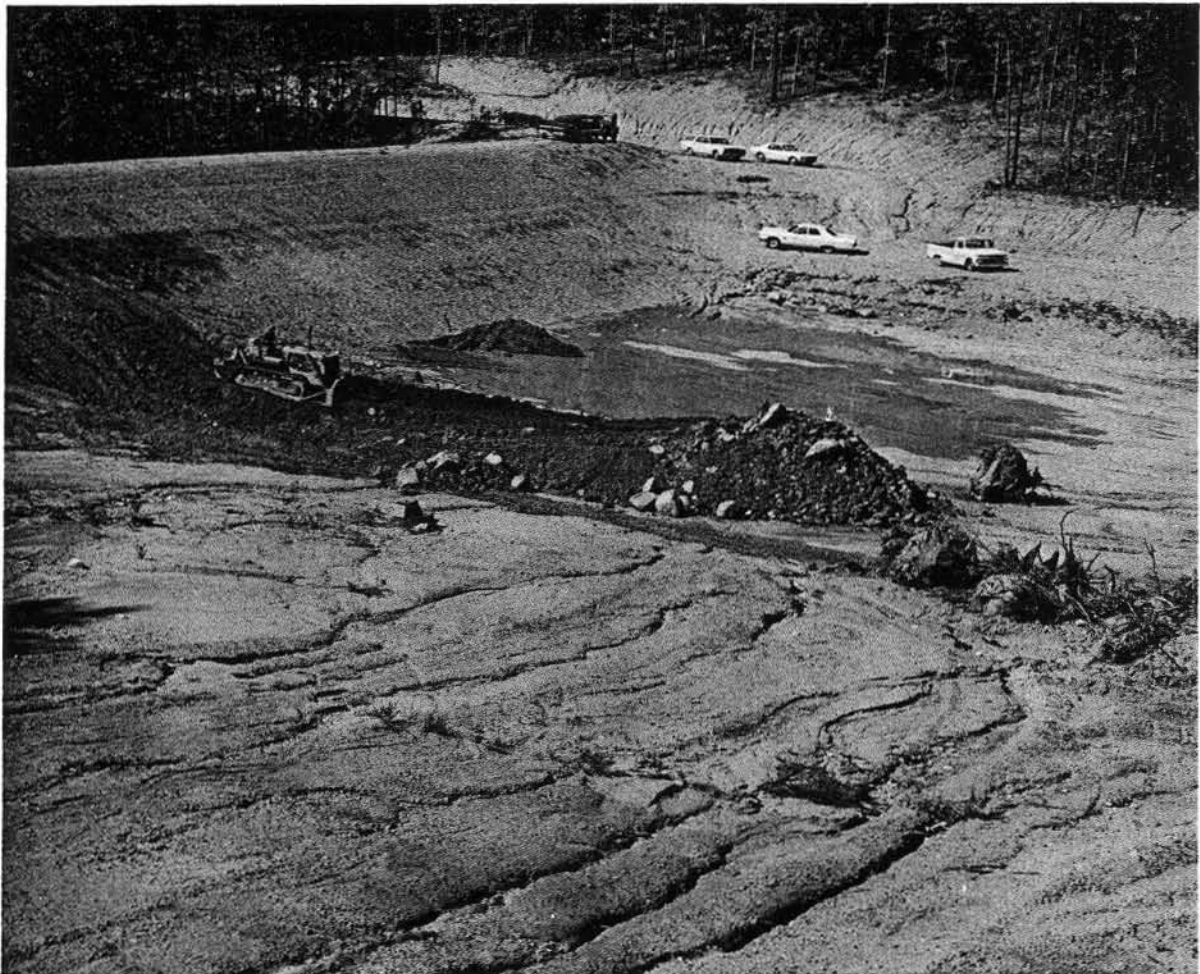
Figure 22

*To prevent leakage under a dam, a clay pad can be put in the lake bottom. Photo by Jerry D. Vineyard.*

venting water from entering the bedrock. Padding is used mainly in very small lakes where the entire basin below the waterline can be covered (fig. 22).

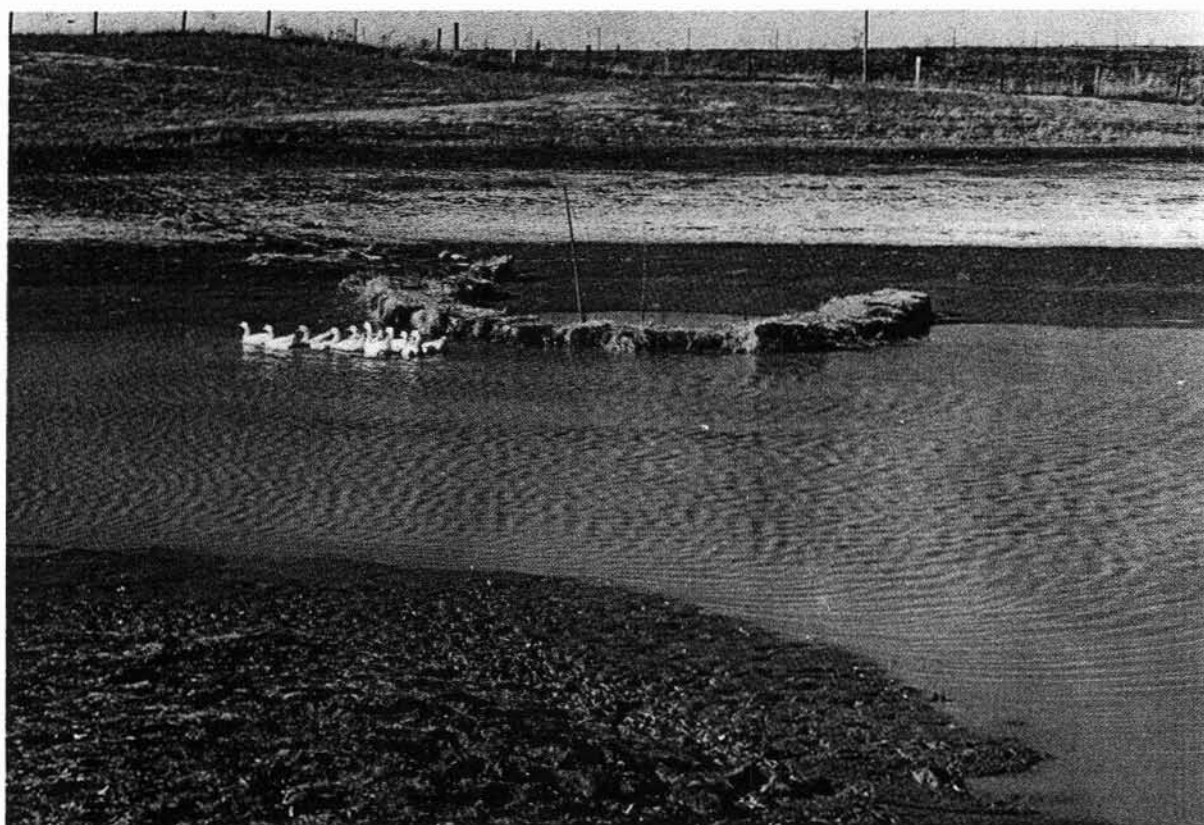
Figure 24

*Siltation of a lake can quickly destroy its usefulness. Photo by Jerry D. Vineyard.*
